So..... Most of us know about the issues that some have had with their instrument cluster going dead. Some have had it happen while riding while others have had it happen after changing the battery, pulling the dash, etc..... My cluster recently took a crap on me after pulling it just to do a headlight bulb change. I pulled the connectors, changed the bulb, and the dash never came back on after I plugged it back in with the exception of the oil pressure, kickstand, and neutral lights. Every other function, including the backlights, were dead as hell. No speedo, no tach, no readouts at all. Incidentally, my dash was replaced under warrantee while the original owner had it.....

Anyways, since I head up a rather large electronics repair facility and have dealt with electronics for over 20 years, I figured that I would be better off taking a look to see if I could figure out WTF was wrong. I mean, what's the worse that could happen? I guess I could screw up something that was already broke..... Screw it, I'm going in!

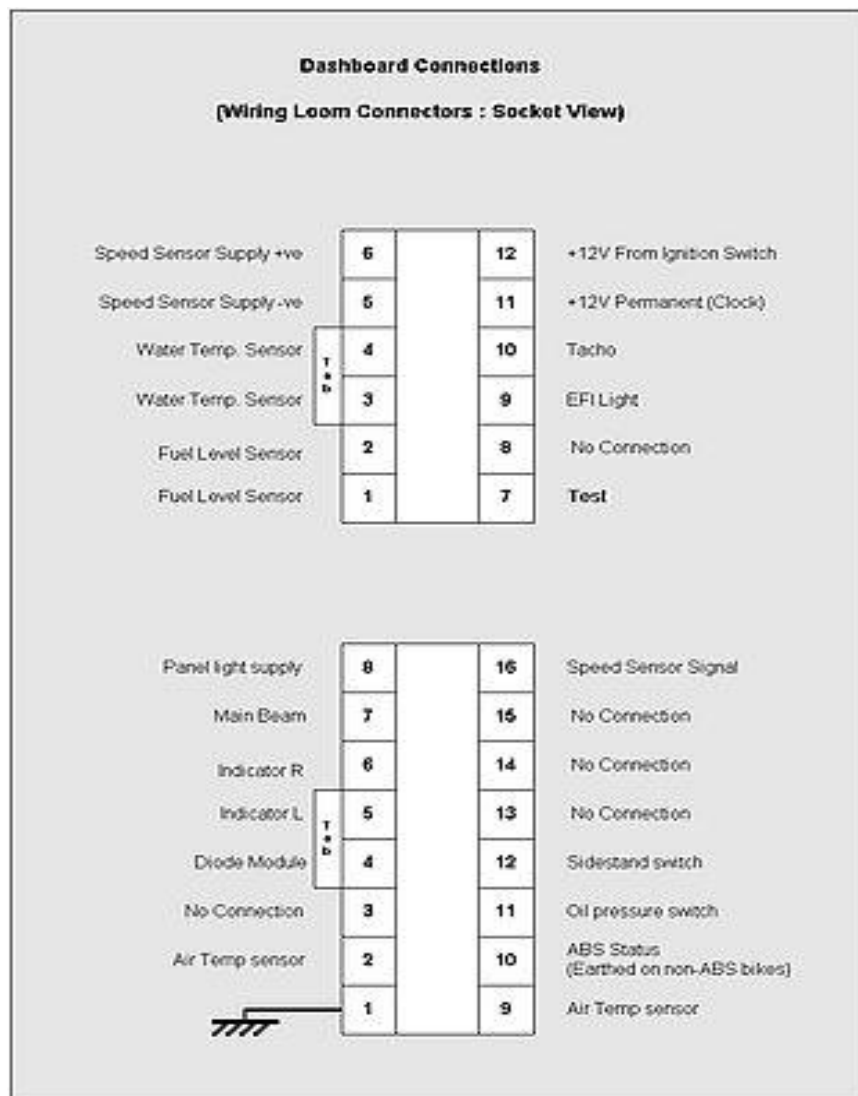
Wiring harness side.....

Next we have a couple pics of the connector pin out diagrams.....

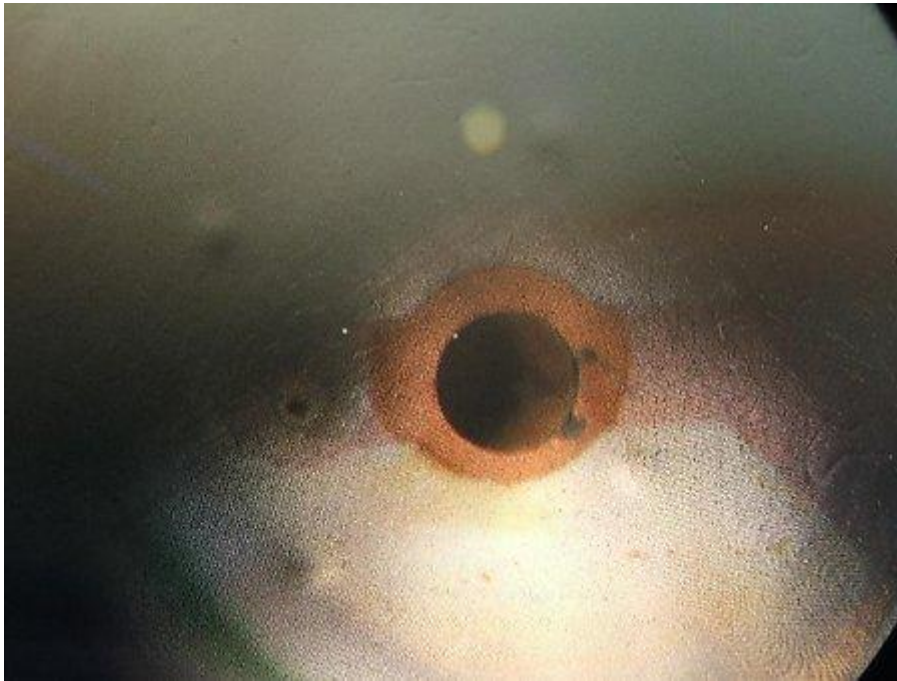
Here is a microscope view of the capacitor mounting pads. You can easily see that there is NO solder to make a connection:

he track from the diode to the regulator passes through the board at the capacitor connection. If the through-plated hole is good, no problem. If the plating is poor or cracked, the then when the board is first soldered the solder does not run up through the hole to make a good joint on both sides of the board, and the through plating is the only connection. If there is a crack in the plating, it may make so-so contact for a while, but eventually it will fail and then the dashboard 'dies'.

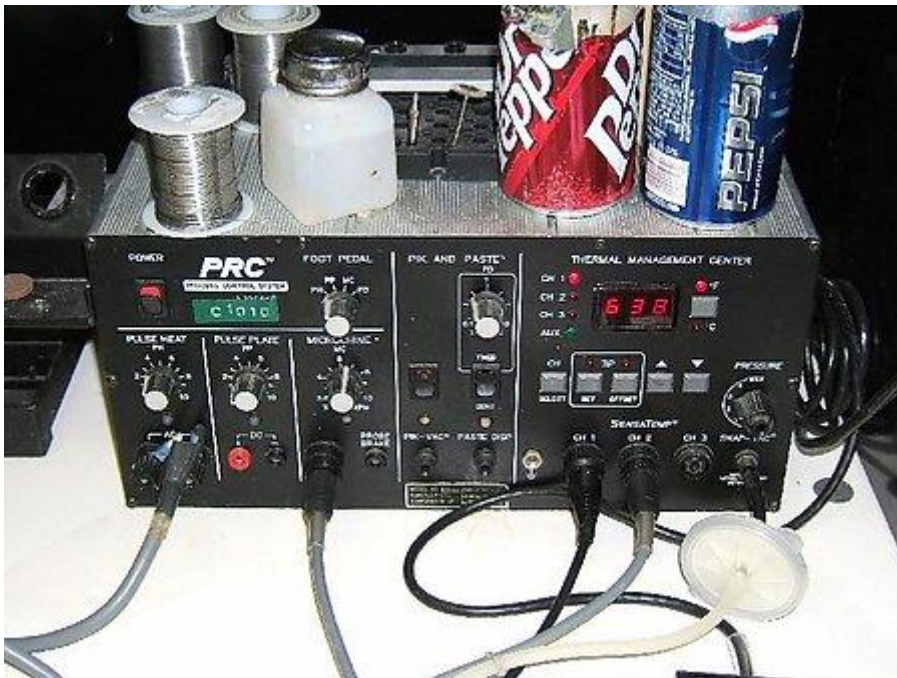
This is a pic of the micro miniature soldering station I used for these repairs, but you can do it with a low heat soldering iron without too much trouble.
